Low Impact Development Best Management Practices Comprehensive Overview and Case Study

In Partial Fulfillment
of the Requirements for the Degree
Master of Science
in
Earth and Environmental Sciences

by
Graciela Rivera
June 2020

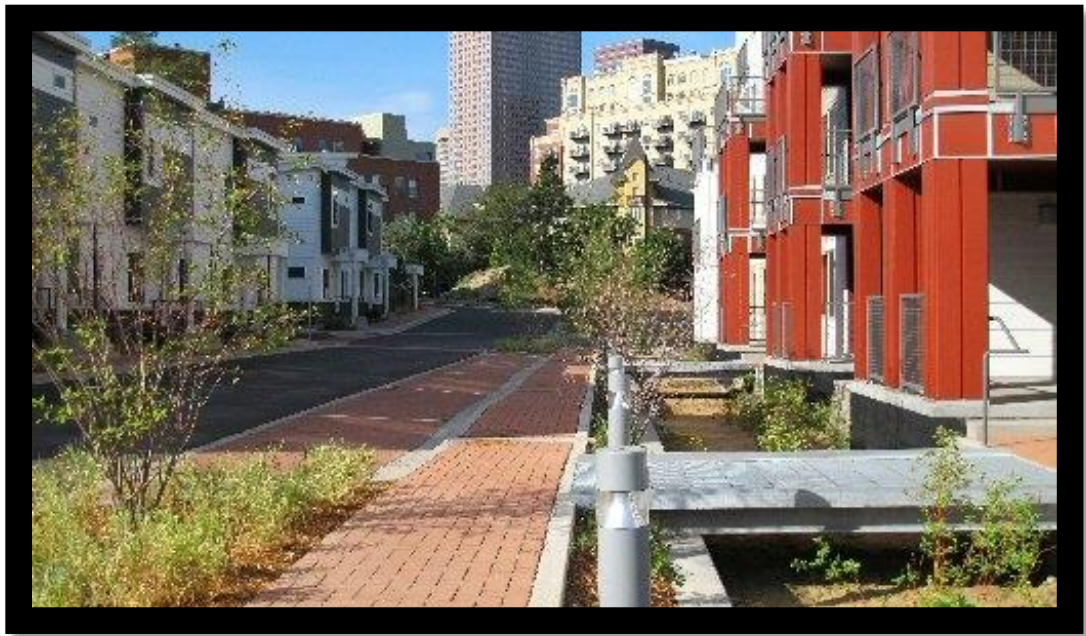
Figure 1. Example of Rain Gardens and Permeable Pavements LID. (2)

Low Impact Development (LID) is rapidly becoming an alternative practice for managing stormwater in California, due to its notable success in other states. Interest in LID, rather than traditional stormwater control applications for residential developments, has increased in the past several years (1). In addition to management and water sustainability, LID practices aid in protecting and enhancing water supply and quality. Figure 1 below shows several examples of rain gardens and permeable pavements, LID practices implemented in Denver, Colorado.

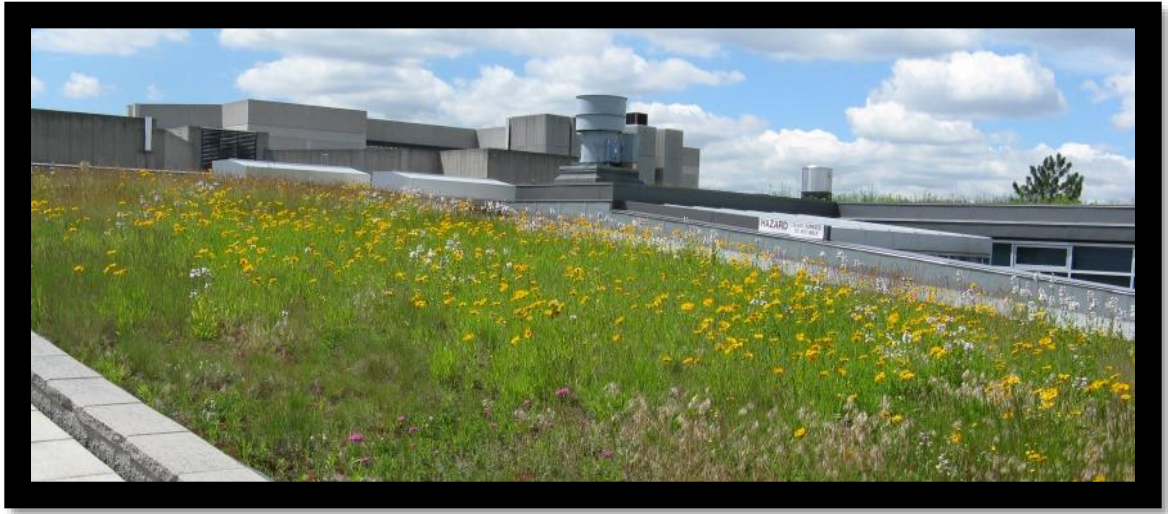
Figure 2. LID Biofiltration Swale. (5)

As can be seen in Figure 2 below, these LID practices can also integrate plants and other greenery, adding to the aesthetics of the facilities that implement best management practices. What cannot be seen in Figure 2 is the low or hollow design of the biofiltration swale for the best collection of water.

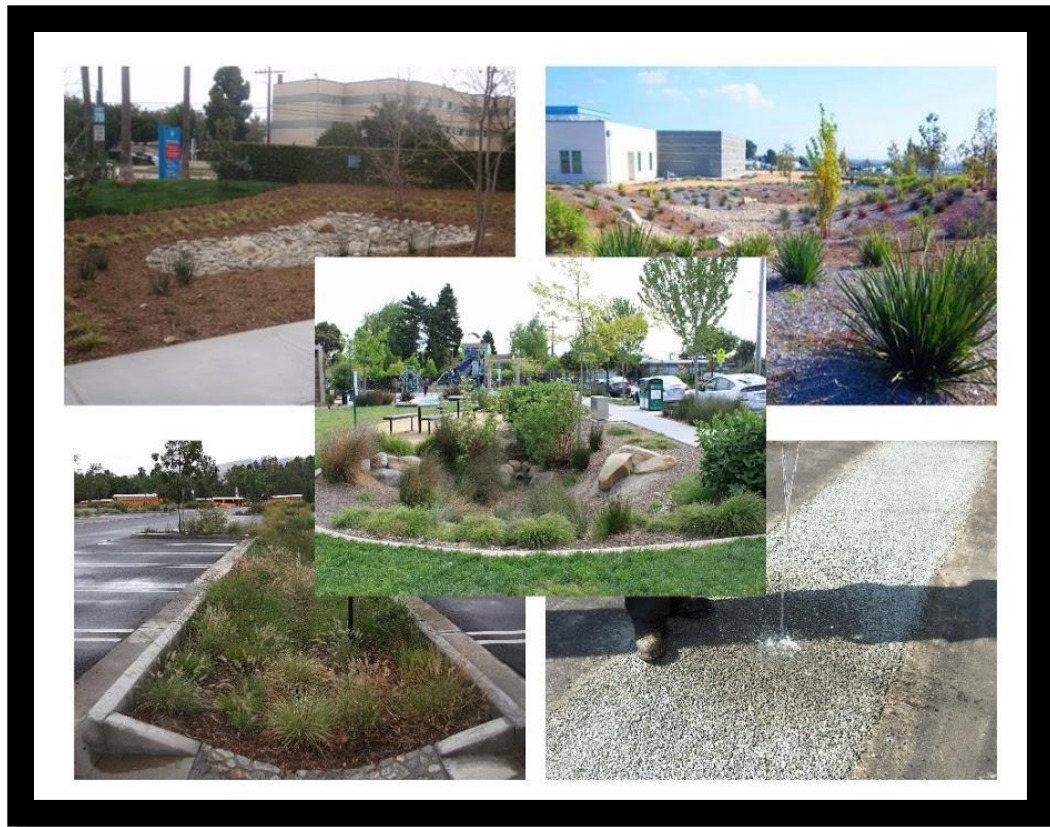
Figure 3. A collection of Established BMPs in California. An Infiltration Basin (top left), Bioretention Area (top right and centered), Biofiltration Swale (bottom left), and Porous Asphalt (bottom right) (12), (13), (14), (15), (16)

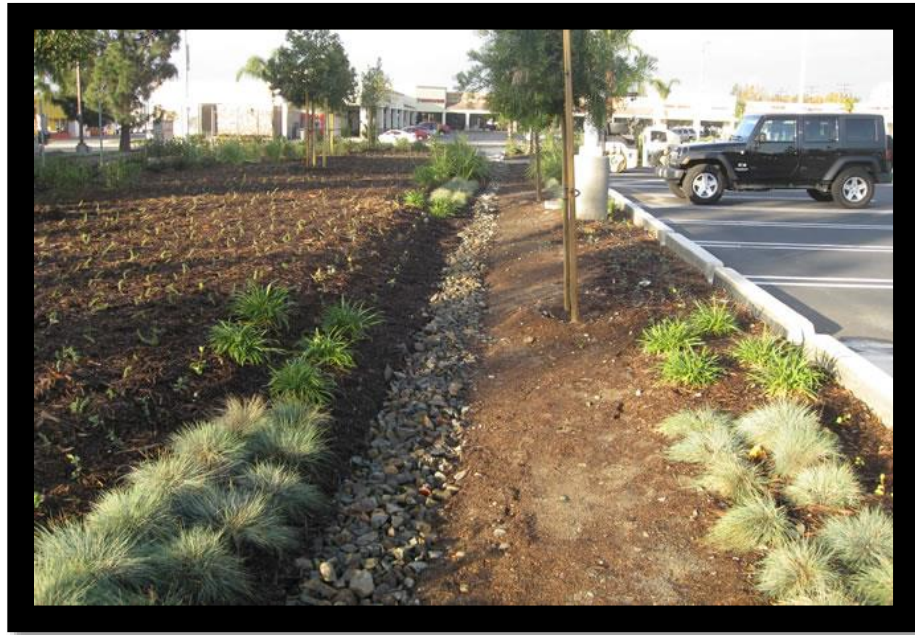
Figure 5. Bioretention BMP in Fontana, California. (19)

Bioretention cells are depressed areas in developments that are created to accept stormwater and redirect it for controlled absorption. This method essentially works with gravity to retain water and treat runoff immediately following a storm. Bioretention cells are generally found in rain gardens, on rooftops, and within landscaping, both in residential and commercial locations, and are usually covered by mulch and decorated with perennials, trees, or other shrubs (4). Figures 4 and 5 below show 2 examples of bioretention BMPs. Figure 4 is in Downey, California; Figure 5 is from the Kaiser Permanente Hospital in Fontana, California.

Aside from what bioretention BMPs do for stormwater, a development can still hold an aesthetic view by using plants and hardwood bark. Runoff is strategically guided to a shallow depression in the landscape where stormwater naturally collects. When a storm occurs, the runoff will collect in these areas and begin to percolate through the soil. The soil in the BMP is engineered to filter common pollutants as water runs through it, similar to a filtration column. The filtered water continues to collect and the overflow is then guided toward storm drains.

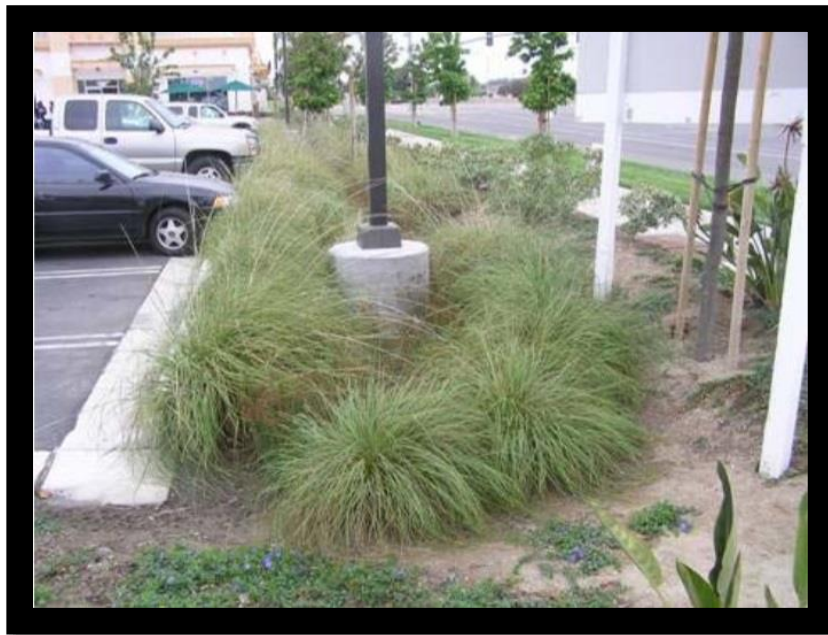
Figure 6. Biofiltration Swale in Oxnard, California. (18)

capture stormwater. As an added benefit, the rate and amount of runoff is reduced swiftly by biofiltration swales (21). The swales are planted with a variety of vegetation intended to collect large items from stormwater runoff such as trash, sediment, and oil-based pollutants. During a storm, the runoff collects in the BMP and permeates at a slow rate. Filtration, in collaboration with settling sediment and infiltration, will begin to treat the stormwater for pollutants usually found in runoff. Following the removal of these pollutants, the water tends to run through at a faster rate. Unlike bioretention BMPs, bioswales do not reduce the quantity of runoff entering or leaving the site, because pipes buried below this BMP transport the treated water offsite and into the traditional stormwater system. Figure 6 shows an example of an established biofiltration swale in Oxnard, California.

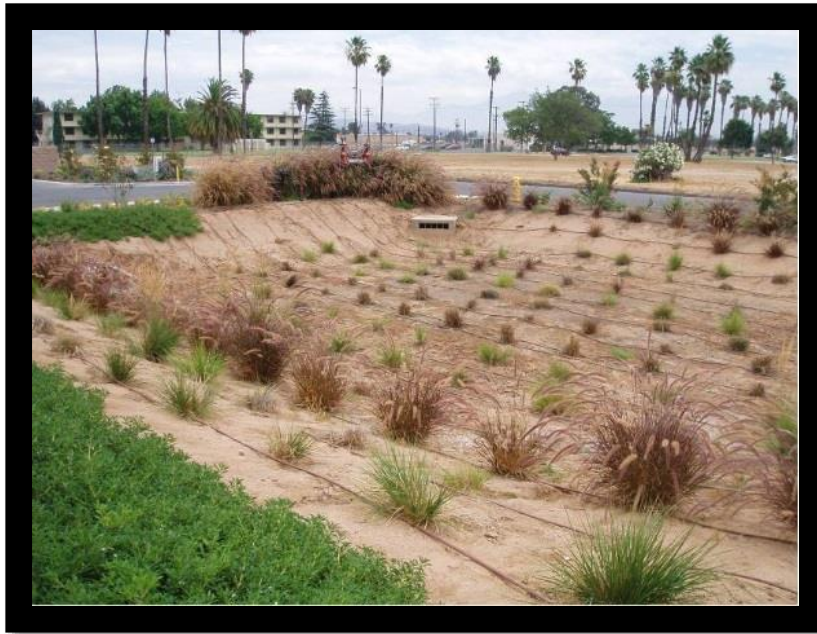
Figure 7. Example of an Infiltration Basin. (18)

Infiltration basins are small, shallow, and bowl-like basins specifically designed to collect stormwater into the soil through infiltration. Infiltration basin designs can vary by region, due to the nature of site soils, which also depend on the condition of the pre-development. Infiltration basins differ from detention basins, in that infiltration basins lack design measures and standards. The characteristics of the soils on a site pose the greatest concern regarding this BMP design process (8). Due to their shape, they are like small pools that are designed to use permeable soil to collect stormwater and infiltrate it into the groundwater. These BMPs are generally referred to as recharge basins, due to their ability, among other applications, to recharge the groundwater beneath them. Infiltration basins also assist in the treatment of the collected water as it flows to surrounding waterbodies; it achieves this by capturing the stormwater runoff and averting floods and erosion attributed to downstream flow. Infiltration basins stand out from other BMPs in their effectiveness by not only removing pollutants from the runoff but also decreasing the magnitude of the flow downstream. The water collected in the basin cannot be removed or released, except through natural processes, which decreases the flowrates downstream. The water can only be evaporated, infiltrated, or overflowed during a major flood. Due to soil requirements by certain sites, infiltration basins can have the largest number of problems with installation. An example of an infiltration basin is shown in Figure 7.

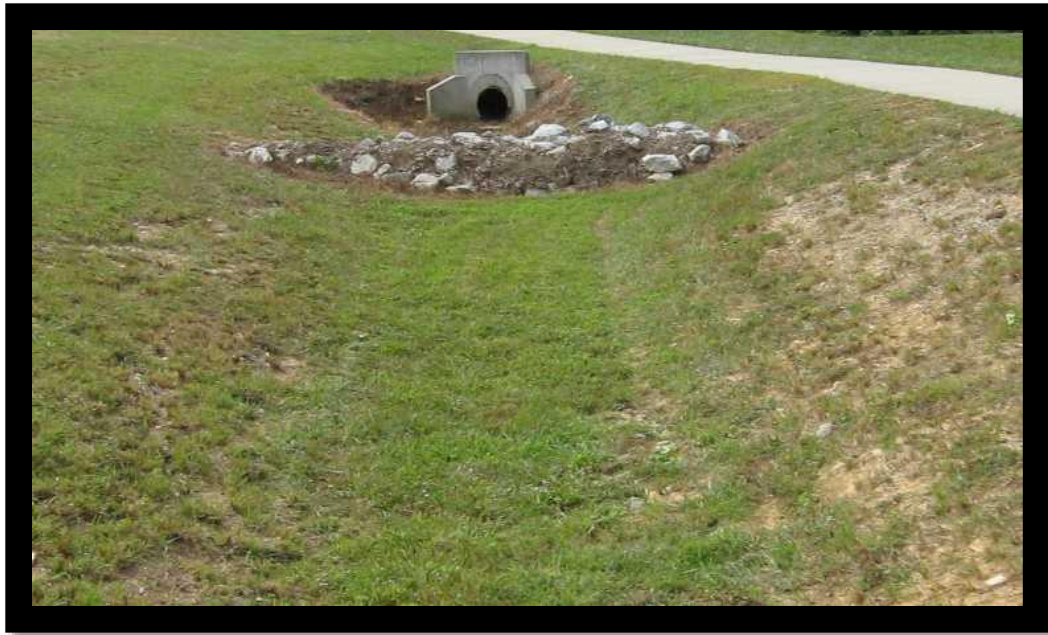
Figure 8. Grassy-Swale Infiltration Basin. (23)

Unfortunately, Infiltration basin BMPs have shown the least amount of success compared to other stormwater management practices (22). Although infiltration basins might have a difficult application and have shown little success, they have become the most popular, due to their many functions in water retention, water quality, and groundwater recharge. Figure 8 and figure 9 show more variation in the infiltration and biofiltration basins. Figure 8 shows a small infiltration basin that has grass planted in and around the basin. Figure 9 shows a small biofiltration basin that has more plants located within the basin than the previous example.

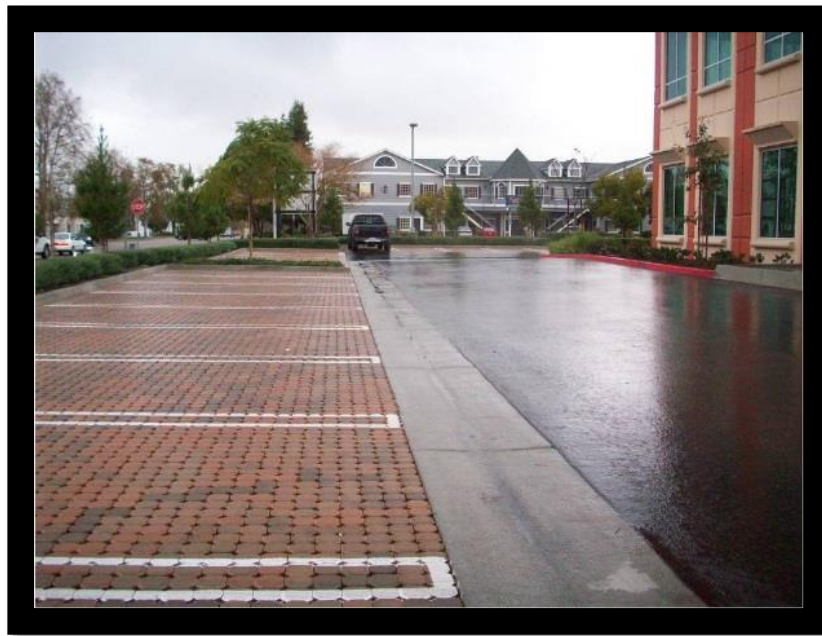
Figure 10. Pervious Pavement in Redlands, California. (18)

Permeable pavements, also known as pervious pavements, are BMPs specifically designed and utilized to control stormwater runoff on paved areas. Typically, this BMP is used to replace parking lots, sidewalks, driveways, and emergency lanes, due to its defined function of readily collecting stormwater as part of an LID (6). Figure 10 shows an example of a permeable pavement BMP implemented in Redlands, California.

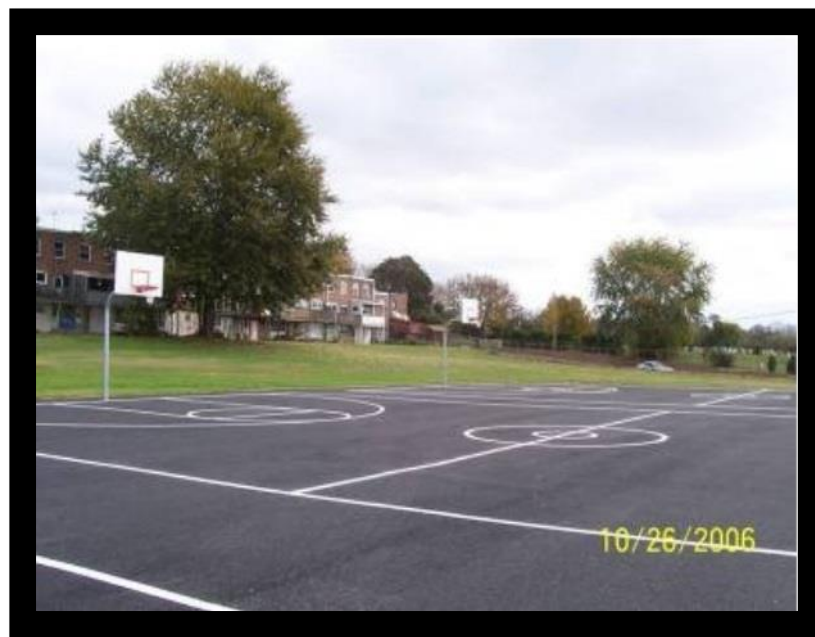
Figure 11. Pervious Asphalt Basketball Court. (18)

flood control measures. With permeable pavements, the water will infiltrate through the pavement to the ground below; this will then decrease the amount of urban runoff, since the water will percolate through the ground, imitating natural processes (25). Adding infiltration abilities to developments allows LID to serve as a stormwater management system by reducing the stormwater runoff significantly. The removal of pollutants from impermeable surfaces has been successfully seen in low impact developments, specifically permeable pavements (26), (27). These pavements have been previously used in developments to ensure, control, and quantify water quality. Figure 11 shows permeable pavements are typically applied to parking lots, walkways, and sidewalks, but can easily replace any traditional pavement. Both private developments and municipal stormwater programs can implement permeable concrete.

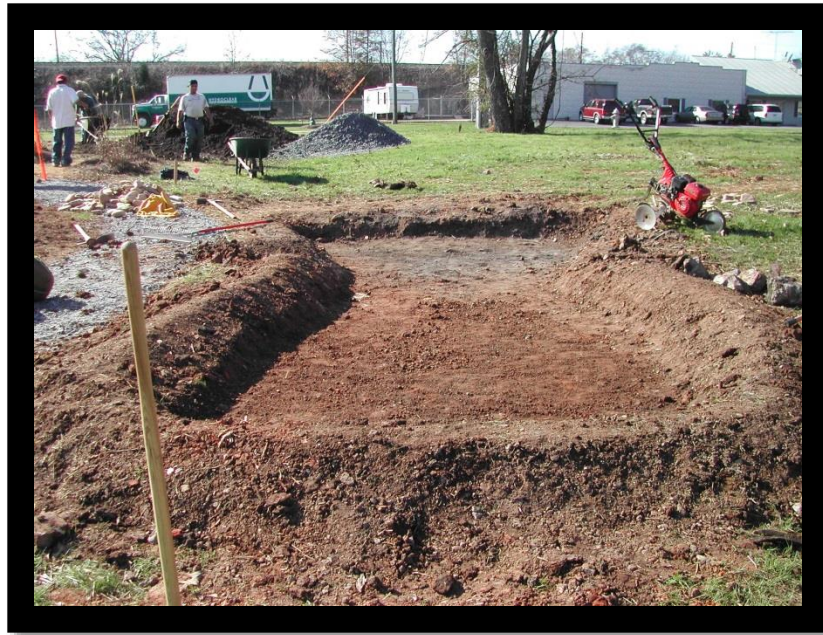
Figure 14. Bioretention Cell Construction. (32)

The implementation of LID BMPs, like everything else, has a cost. In an effort to motivate communities to implement these low impact developments best management practices, there is a need to understand and examine the total design life expenses of LID BMPs. There have been many studies associated with the effectiveness of LID BMPs in reducing runoff and pollutants from storm events in urban areas, but the economics of LID BMPs have not been well researched (31). Figure 14 shows the rain garden bioretention cell during construction; this is from the Facility's actual construction.

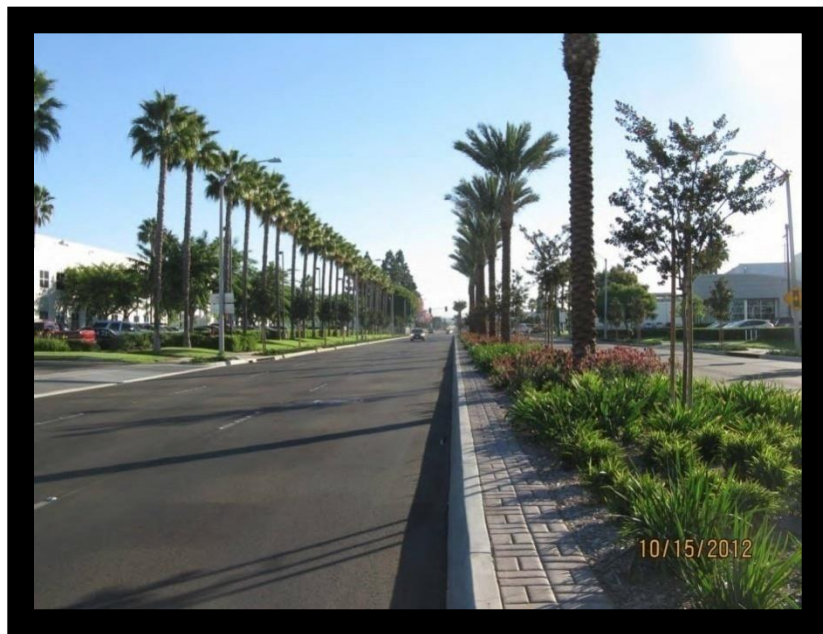
Figure 20. Completed Low Impact Development in Orange County. (35)

both require an assessment of the soil and its permeability prior to installation. These assessments will also take into consideration the treatment required to remove solids. Overall it is seen that biofiltration systems are the most cost effective BMP to install and maintain on any type of property. However, if that BMP cannot meet all of the runoff management needs prescribed in the corresponding MS4 permit, other BMPs will need to be applied as well. Figure 20 shows an example of how the Orange County BMPs will look after construction is completed.

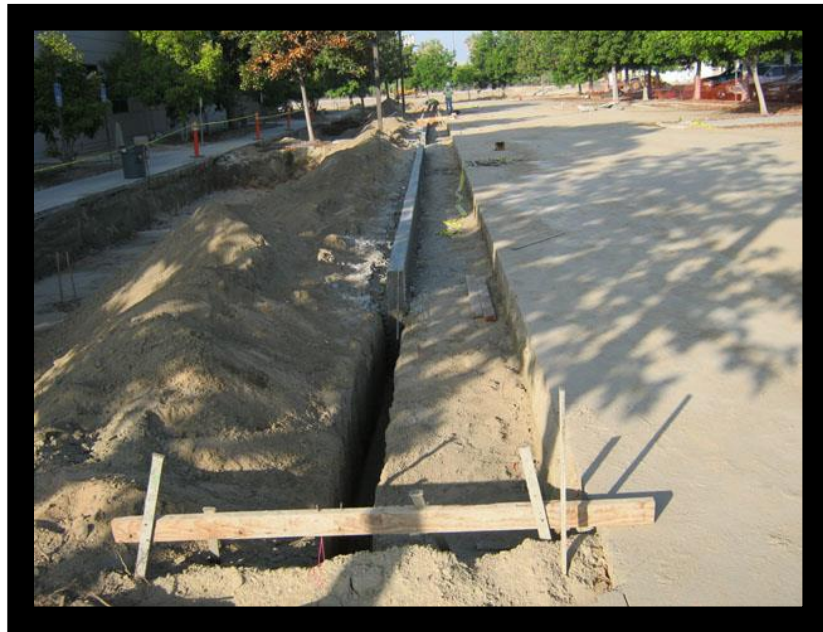
Figure 21. Construction of the Facility's Pervious Asphalt BMP. (30)

The massive LID BMP project that the facility underwent to develop its demonstration facility cost a total of \$2.5 million to implement. Figure 21 shows the construction of the Pervious Asphalt BMP at the facility during the actual construction.

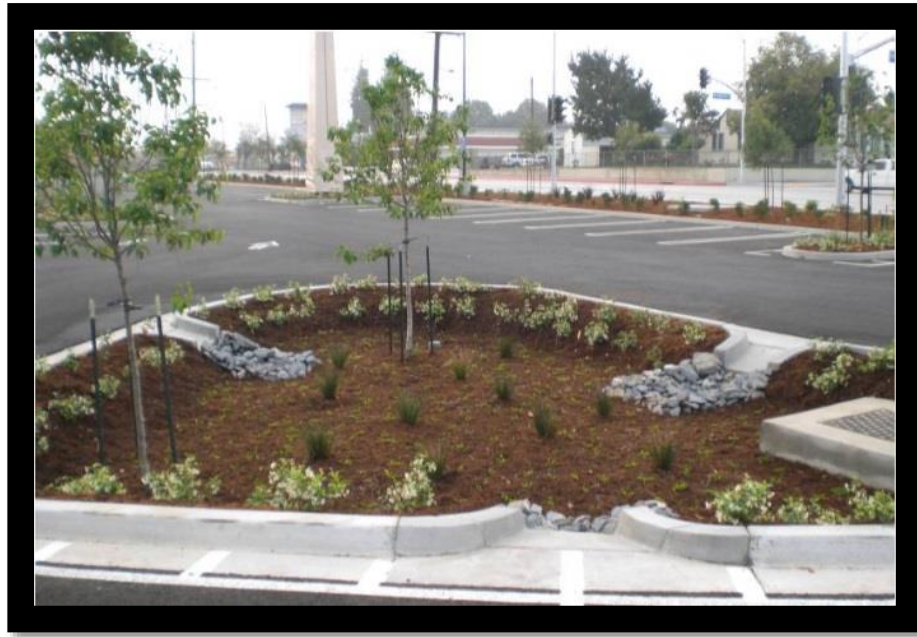
Figure 24. Bioretention BMP. (18)

have shown to still infiltrate runoff while frost is present. Figure 24 shows another example of a bioretention cell.

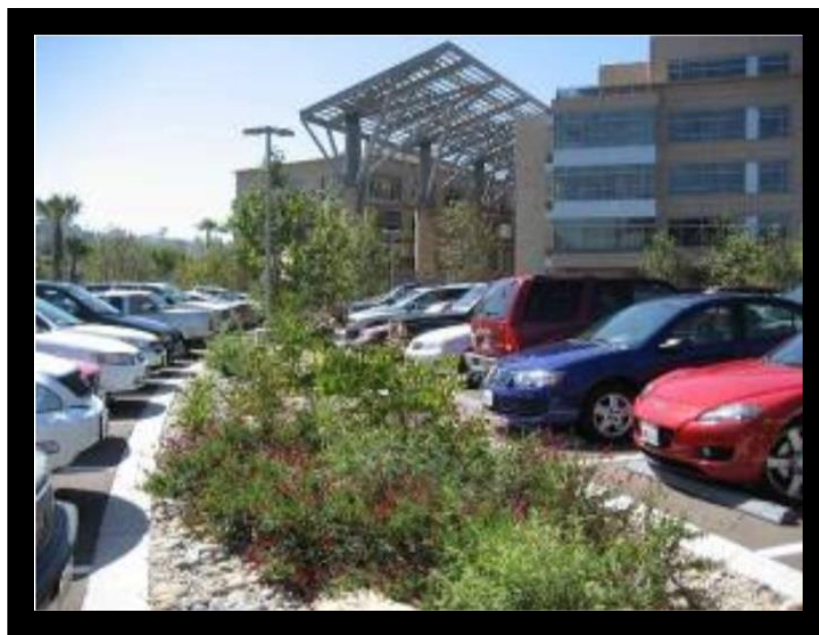
Figure 25. Bioretention BMP. (18)

introduced that did not appear high in the influent (6). The problem with a lack of removal in phosphorus is commonly seen due to the engineered soil used in the filtration system. An alternative medium should be considered if it demonstrates high levels of phosphorus during examination, in order to reduce the export of phosphorus into the effluent (4). Since nitrate is a negatively charged ion, this causes the soil particles to reject it rather than clutching onto it like they would with other pollutants, like metals. A plausible reaction for the low removal rate of nitrate-nitrogen explored in other studies is the creation of nitrate-nitrogen between storm events, through mineralization and nitrification from nitrifying bacteria as well as other sources of nitrogen (4). Figure 25 shows an example of a bioretention cell at the CalTrans district headquarters in San Diego, California.

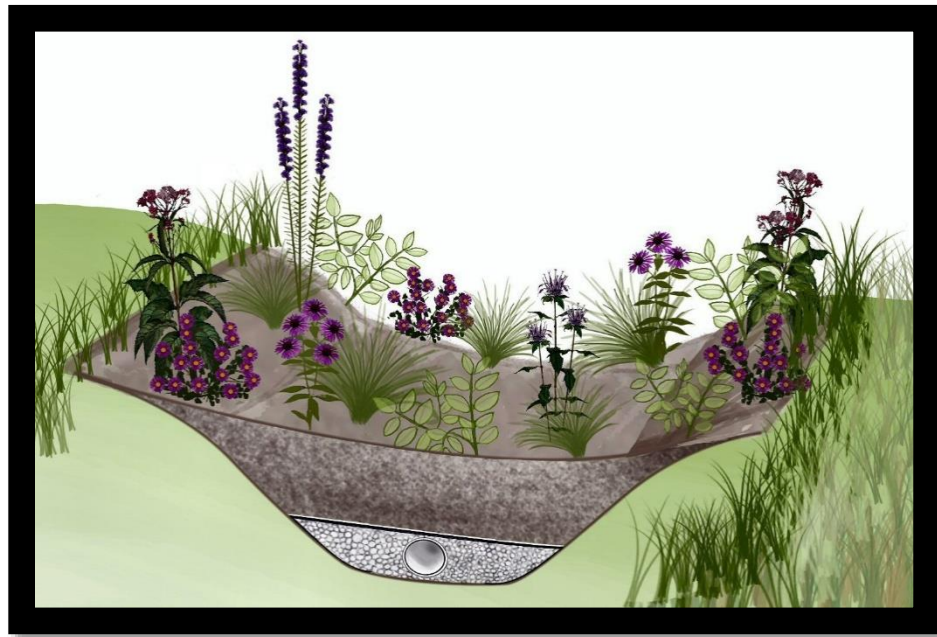
Figure 26. Cross-section of a Biofiltration Swale. (39)

Biofiltration and Infiltration Practices. Biofiltration systems, are employed to collect stormwater and use the natural microbes in the system to absorb pollutants. Infiltration basins, on the other hand, collect stormwater and work specifically to recharge groundwater. Figure 26 shows an illustrated cross-section of a completed biofiltration swale.

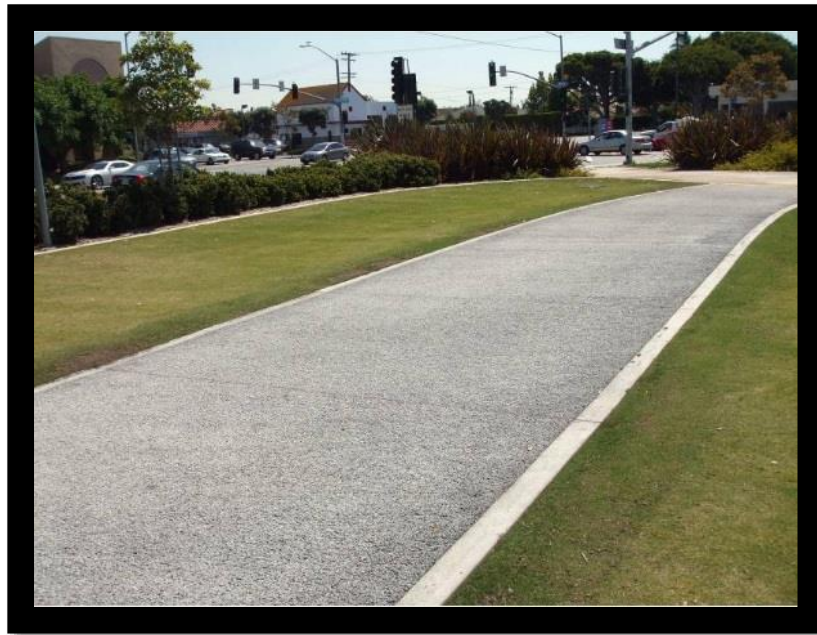
Figure 29. Porous Concrete BMP. (18)

which will help reflect more light compared to traditional black pavements (29). The durability of permeable pavements ranges from 12 to 15 years in cool environments and up to 30 years in warm environments; which is similar to traditional non-porous asphalt surfaces. Most importantly, pavement systems pose no threat of pollutants to the groundwater they recharge (4). The lifetime of the system is related to the maintenance provided. In order for it to live its expected lifetime, it requires a great deal of maintenance, including washing, cleaning, and replacement of soil after time. Figure 29 shows an established porous concrete BMP.

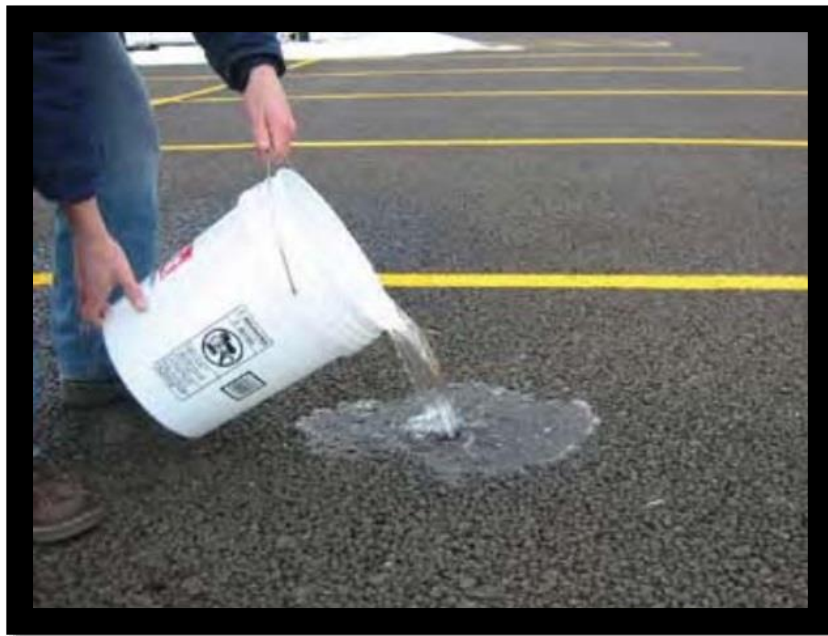
Figure 30. Permeable Asphalts. (18)

The potential for contamination is low in residential areas, due to the fact that the pollutants regularly found in stormwater have a high affinity to soil. Even though the system could become clogged, the amount of infiltration it undergoes is still significant (especially when compared to traditional pavements). Research of pavement BMPs on the East Coast has shown that permeable pavers, such as pervious pavements or concrete grid and blocks, can still effectively infiltrate large amounts of stormwater runoff, despite potential clogging by increased loading of fine particles onto the surface. After replacement of the clogged media, the infiltration rate of the pavers will increase even more (4). Figure 30 shows decrease in runoff allowed by the infiltration abilities of the greater porosity of permeable asphalt.

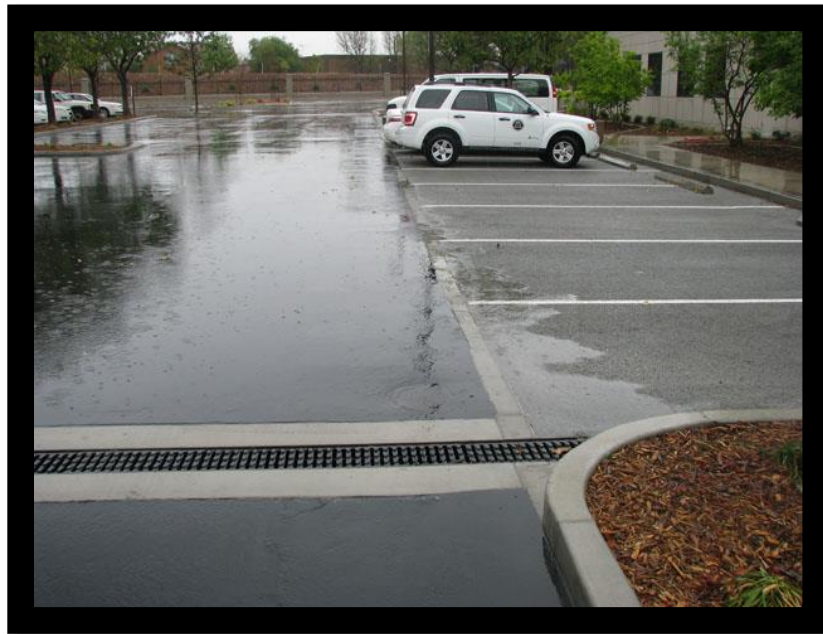
Figure 31. The Facility's Porous Concrete During a Storm. (30)

Both concrete types, filter or not filtered, showed reduction in several constituents. Oil and grease were removed by both the concrete systems, but had a higher percent removal by a difference of 16% in the filtered concrete. Figure 31 shows the difference in runoff during a storm event at the facility. The area on the left of the photo is traditional asphalt and the area on the right (the parking stalls) is the porous concrete.

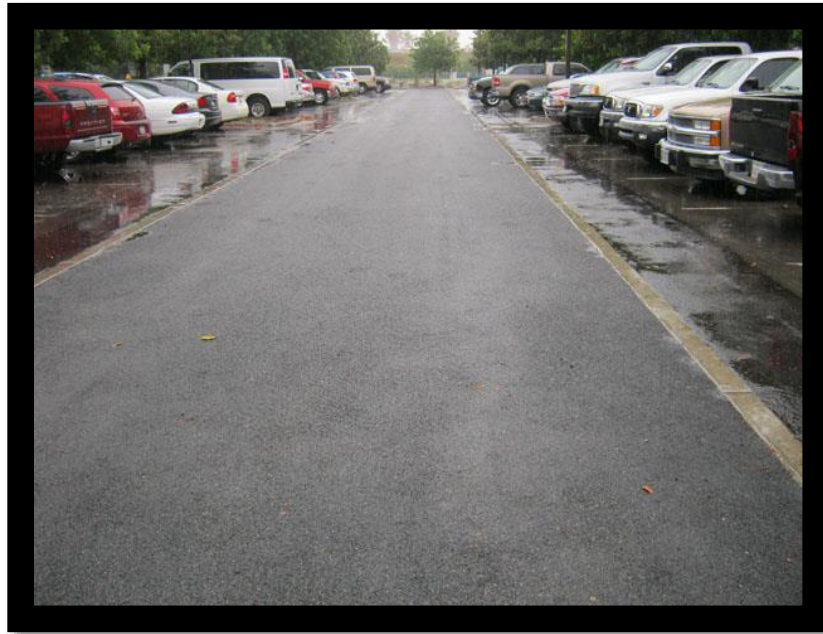
Figure 32. The Facility's Pervious Asphalt Parking Lot. (30)

The asphalts, which are found in the parking lot area, also had similar successes in pollutant removal with or without the filter. The greatest difference was that oil and grease had a positive percent removal in the case of the asphalt without the filter. Oil and grease are introduced through vehicle traffic, and then washed away through runoff. This causes an overexposure to the pollutant and is harder to remove from the runoff. Figure 32 below shows another location at the facility's parking lot, demonstrating the difference between the porous asphalt and traditional asphalt. The traditional asphalt is located on both sides of the photo (with the cars parked on top of them), while the porous asphalt is located in the middle.

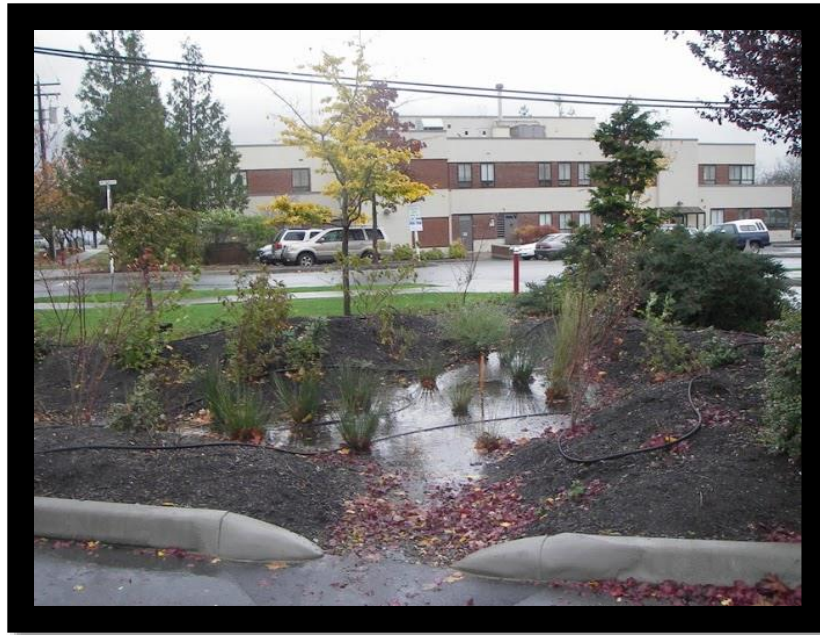
Figure 35. Biofiltration BMP. (43)

Aside from the regulatory considerations of LID BMPs, cost is an important concern in order for implementation to occur. The cost to apply a BMP onto a new or renewed development adds a significant financial stress on developers. This analysis showed that the biofiltration practice had a lower price compared to its counterparts. Biofiltration, however, as can be seen in figure 35 below, is the BMP that covers the least area in a development due to its water drainage properties. This BMP takes so long to infiltrate, a large area would only become a mosquito breeding pool rather than manage the stormwater and its quality. As seen through the case study, this BMP only removed a few of the pollutants measured. Infiltration basins had the same advantages in their cost savings, where the cost for size was among the lowest to implement.

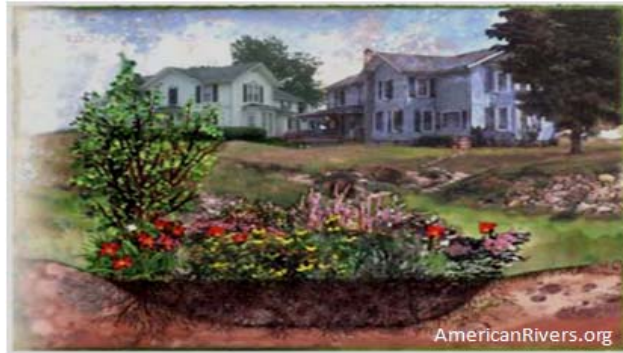
Residential Rain Gardens Reference Sheet

Residential Rain Gardens are defined as small, vegetated basins designed to capture and utilize all precipitation/runoff from small events (i.e. 2-year storm) and serve as a detention facilities for larger events (i.e. 5-year storm and greater). These basins are often fed by down-spouts concentrating runoff from residential roofs or from collection areas near driveways and other paved surfaces associated with a single residence.
